**Re: Transmittal of Compliance Evaluation Inspection Report
Municipality of Cataño Small Municipal Separate Storm Sewer System
NPDES Permit Number PRR040033**

Compliance Evaluation Inspection

Water Compliance Evaluation Inspection Report Form (EPA Form 3560-3) Summary of Findings

Facility Name: Cataño Public Works Facility
NPDES Permit Number: PRR040033
Inspection Date: August 21, 2013

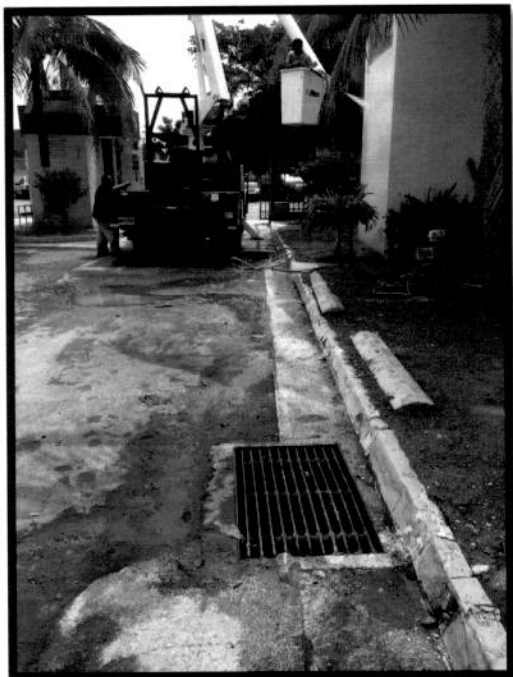
Picture 1

View of the Cataño Public Works Facility entrance and two catch basins.

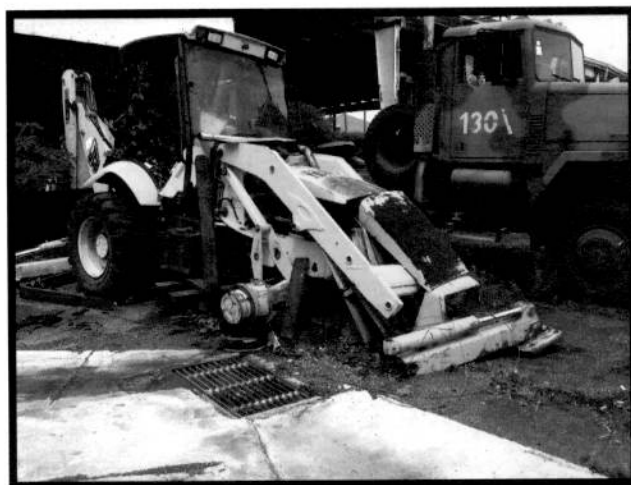
Picture 2

View of the vehicles parked under a roof when not in use.

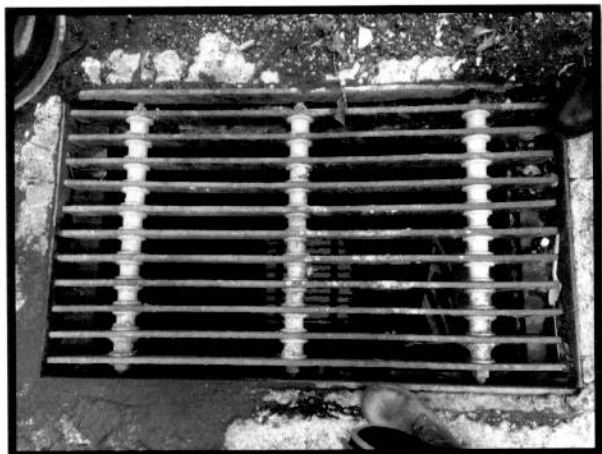
Picture 3

Closer view of a catch basin in need of maintenance.

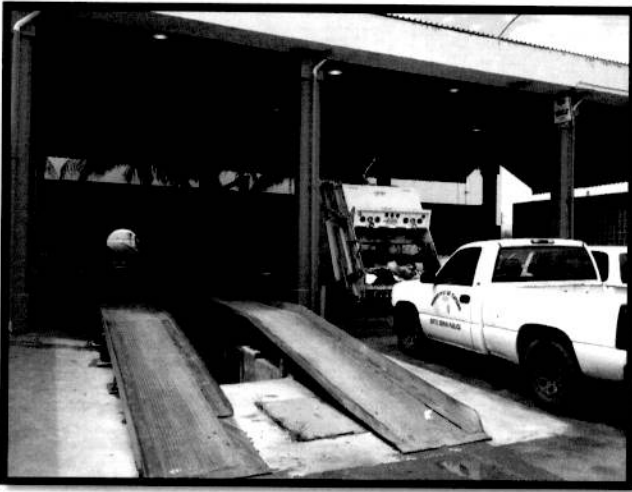
Picture 4

2. The Cataño PWF Workshop is located under a roof, preventing storm water from getting in contact with the pollutants used in the area (see picture 3).

View of the mechanical workshop located under a roof.

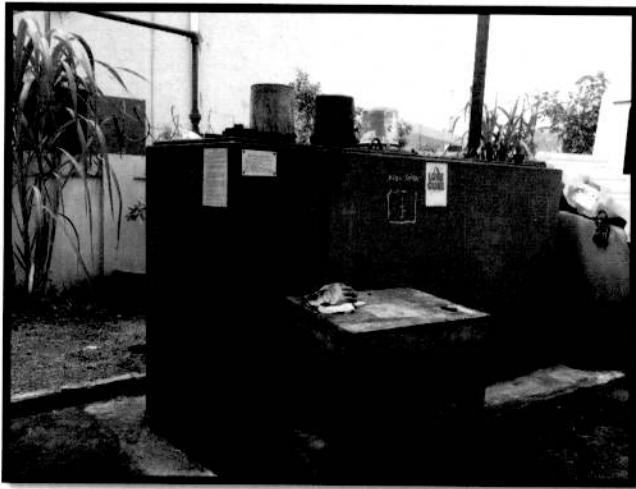
Picture 5

3. The used oil is transferred through a pipe system. The pump was out of service during the inspection. Mr. Torres explained that the pump broke a month ago and they were using 5-gallon buckets to transfer the used oil manually to the tank (see picture 4).

View of the used oil storage tank.

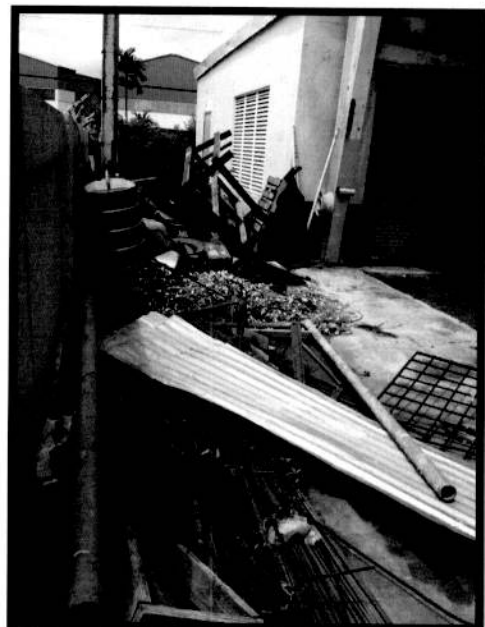
Picture 6

Waste accumulated between the workshop and the storage area. Wood, steel, and post were observed in the area exposed to stormwater.

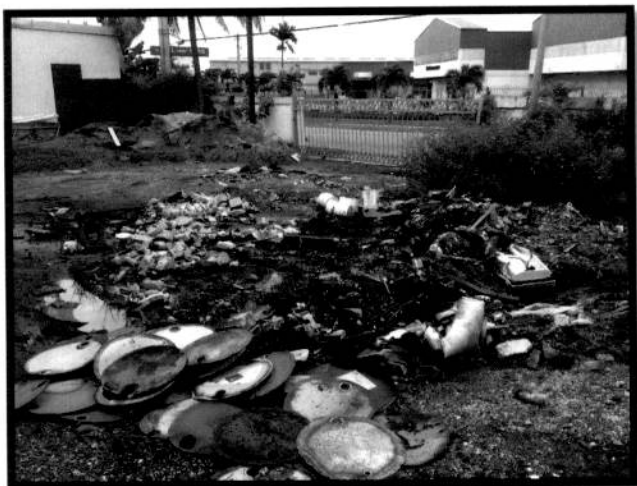
Picture 7

- behind the storage area; drum lids, paint containers, and construction debris were observed (see picture 7);
 - at the west side of the property; abandoned mechanical equipment was observed exposed to stormwater (see picture 8);

View of waste accumulated at the west side behind the storage area of the facility. The waste observed included drums lid, paint containers, construction debris, among others. This area drains into State Road 869 stormwater sewer

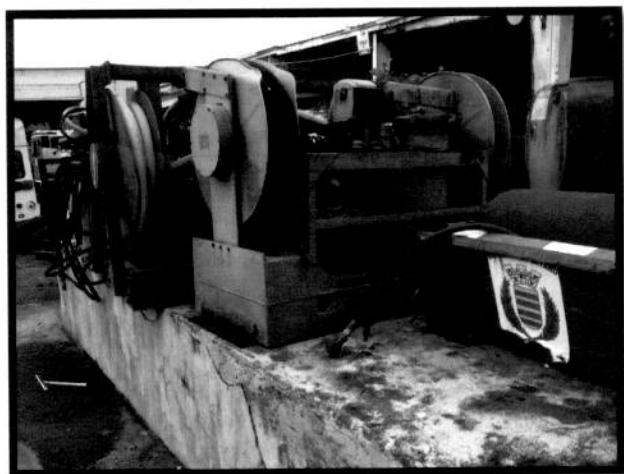
Picture 8

View of abandoned mechanical equipment, exposed to stormwater, on the west side of the property.

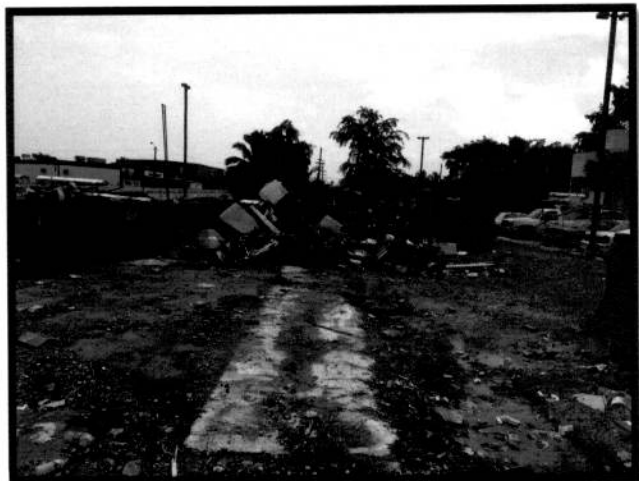
Picture 9

- at the north side of the property; waste was exposed to stormwater without pollution prevention controls implemented. According to Mr. Torres, the waste found throughout the municipality is taken to this area and a private company named Andres Reyes Burgos disposes of it on daily basis. Mrs. Cruz explained that the Municipality is in process of obtaining the permits

View of waste at the north side of the property. The waste observed includes furniture, wood pallets, construction debris, and yard waste, among others.

for a transfer station (see picture 8). The Municipality must implement measures to prevent stormwater pollution and to manage the leakage generated at this area.

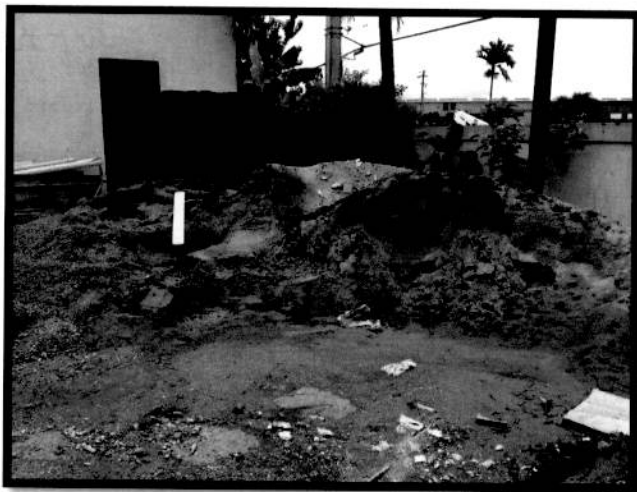
Picture 10

6. Construction aggregates piles exposed to storm water were observed at the west side of the facility without erosion controls implemented. Construction aggregates has eroded from this area and sediments were observed at the stormwater channel located on State Road #869 (see pictures 10 and 11).

View of construction aggregates exposed to stormwater without controls implemented.

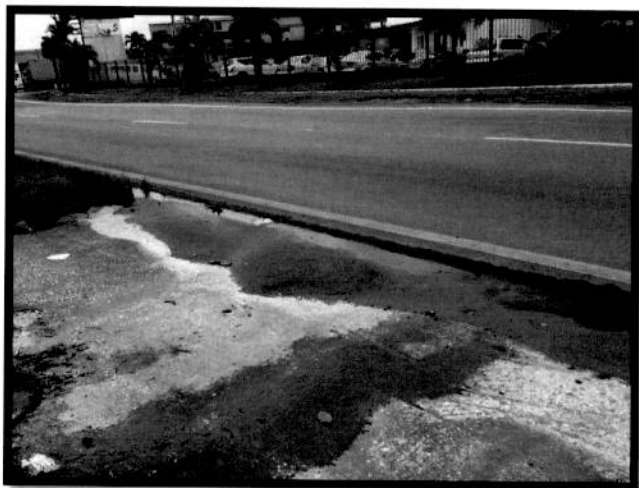
Picture 11

View of State Road #869, water was observed moving from the PWF into the stormwater channel. The north area of the facility drains into this channel. Sediments were observed in the channel.

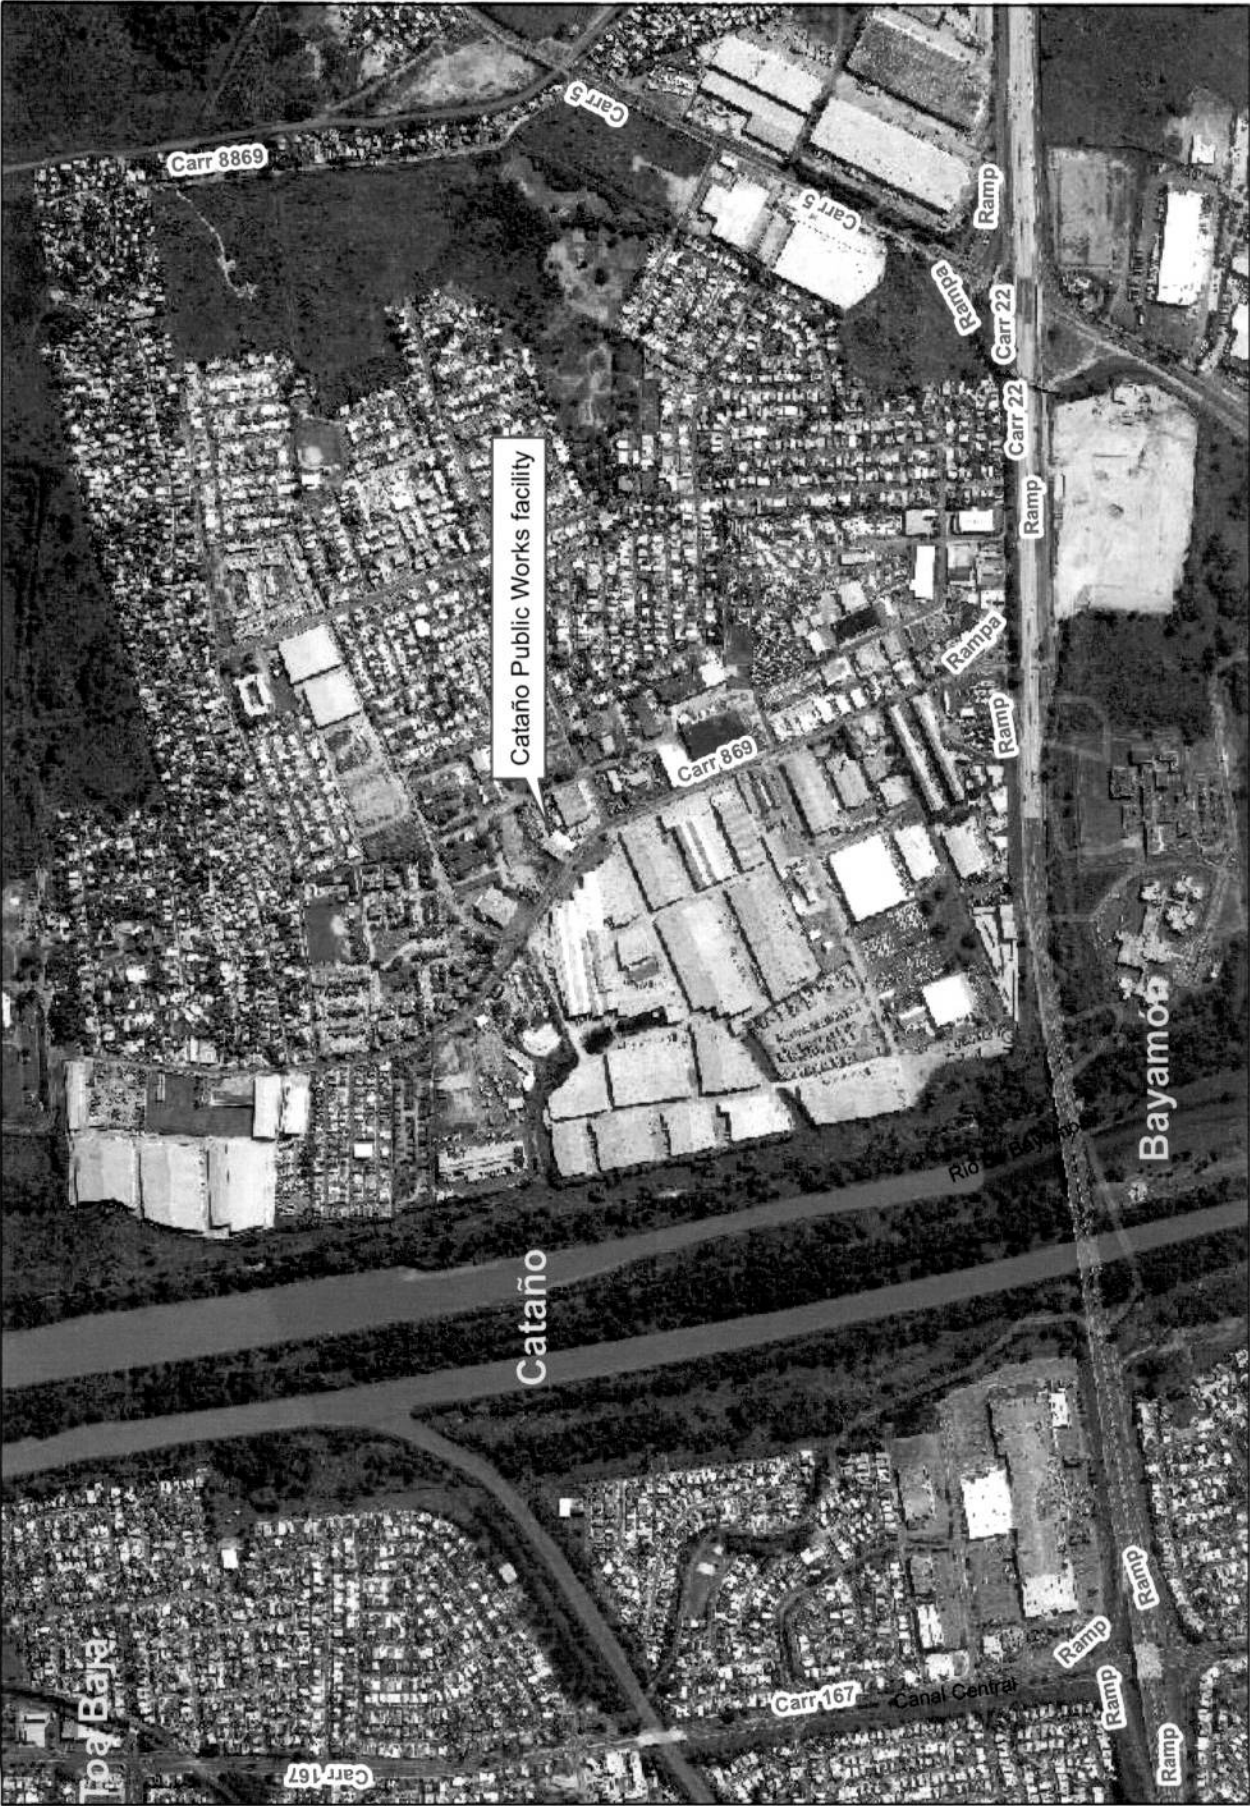
Municipality of Cataño
Public Works Facility Drainage Map

1. The stormwater runoff generated in the PWF flows through a pipe system with four catch basins that runs through the east side of the facility, and discharges into the storm water pipe system on the street (Carr. 19). The stormwater runoff generated at the backside of the facility flows through the ground surface and discharges into the stormwater pipe system located on State Road 869. Refer to pictures 1 and 2 for a view of the stormwater pipe system. The closest receiving water bodies are Rio Bayamón and Caño La Malaria, which are navigable waters of the United States. Refer to Attachment II for the drainage map.
